ASSESSING THE STABILITY OF LANDSLIDES - OVERVIEW OF LESSONS LEARNED FROM HISTORICAL LANDSLIDES IN UTAH

Gary E. Christenson and Francis X. Ashland
Utah Geological Survey

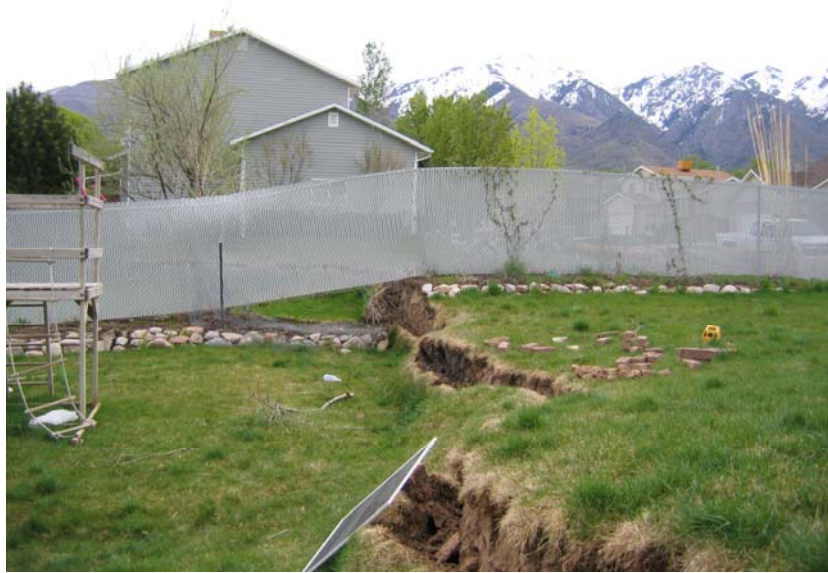
Figure 5. Main scarp of the 2006 Sunset Drive landslide showing small displacement main scarp in the crown of prehistoric landslide. Photo by Ashley Elliott, UGS.

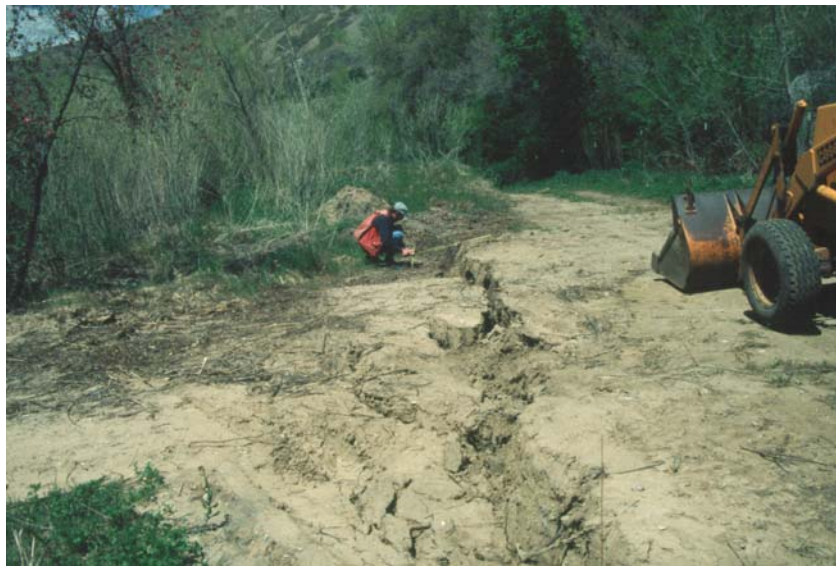
Figure 6. Scarps in the 1999 Osmond Drive landslide showing small displacements within the older landslide complex.

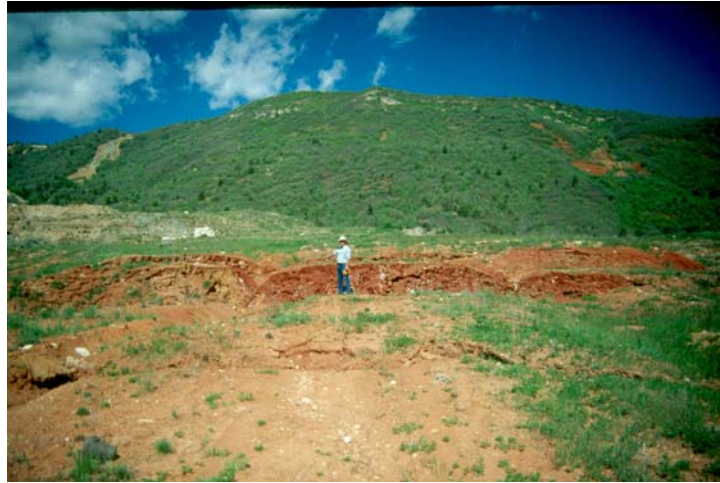
Figure 7. Toe thrust just above natural buttress in the Thistle landslide caused by 1998 failure in head area.

Probably the best example of the potential for continued movement in both the upper and lower parts of a naturally buttressed landslide is the 1983 Thistle landslide. In 1983 the landslide blocked Spanish Fork Canyon and became buttressed against rock in the opposite canyon wall. Heavy equipment was used to mechanically compact and flatten the local slopes of the lowermost part of the deposit mainly to reduce the likelihood of failure of the landslide dam (Shuirman and Slosson, 1992), but also to improve the material to act as a buttress. However, in 1983 during the last stages of movement, the lower part of the landslide overthrust the buttress. Movement continued upslope through 1985 (Duncan and others, 1986). Again in 1998, a significant failure in the head caused up to 7 meters of movement just above the buttress as the lower part of the landslide overthrust the buttress (figure 7; Ashland, 2003b). Movement farther

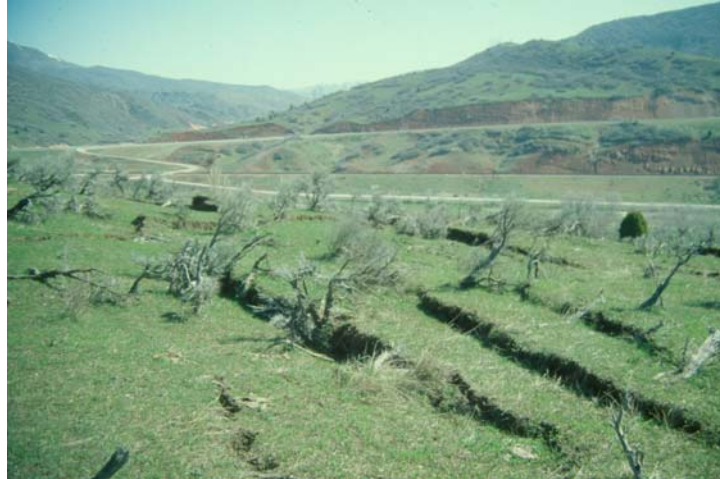
Figure 8. Deformation in 1998 in lower landslide deposits caused by the 1997 Shurtz Lake landslide.

The 1997 Shurtz Lake landslide demonstrated how movement in the upper part of a prehistoric landslide complex can induce movement in the lower part. In 1997, several earth flows in the landslide complex were deposited at the base of a bluff (figure 4) atop the lower part of the complex. The lowermost part of the complex showed signs of incipient reactivation by late May 1997 (Ashland, 1997), and in 1998 nearly the entire lower part reactivated, forming a zone of uphill-facing minor scarps, lateral strike-slip shear zones, and a toe thrust system (figure 8). The total amount of movement of the lower landslide locally exceeded 3 meters (Ashland, 2003b) and would have caused extensive damage to any structures built on the lower landslide deposits.

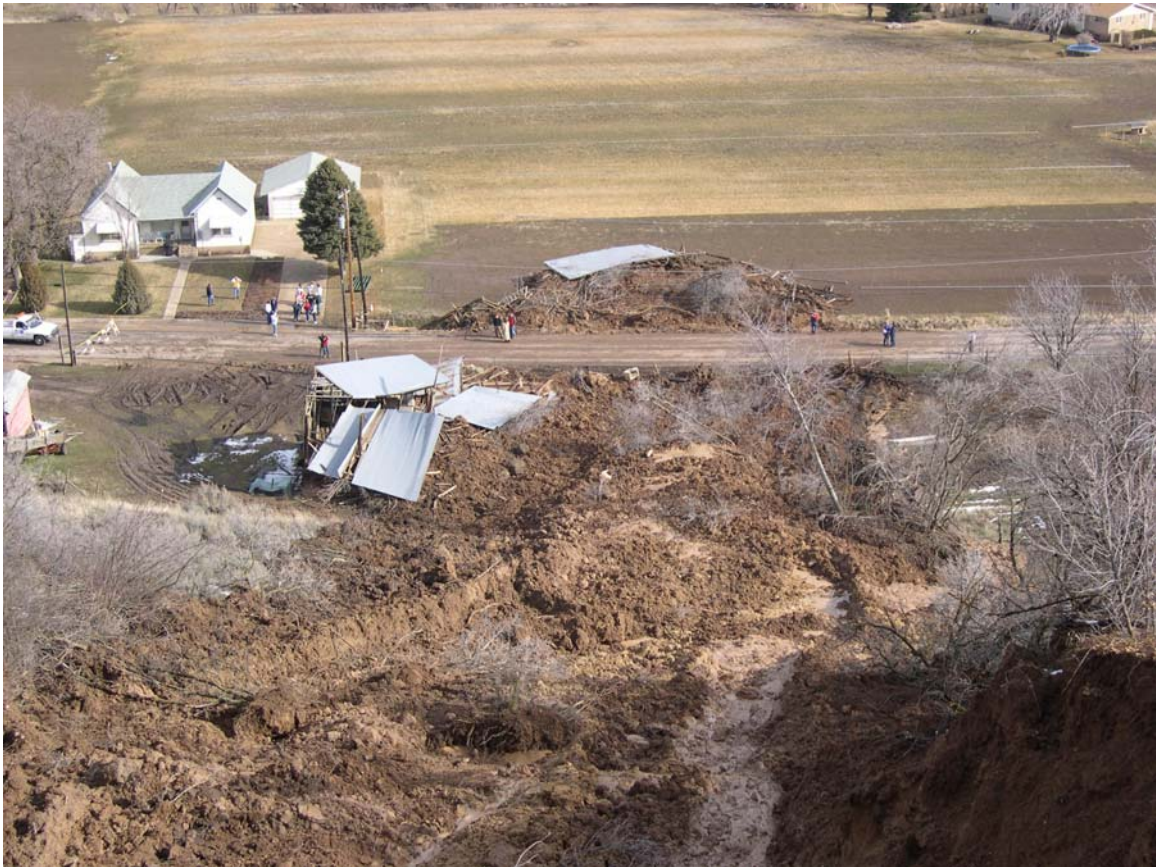
Figure 10. Toe of the 2005 425 East South Weber landslide that ran out over 50 meters from the base of the slope. Photo by Richard Giraud, UGS.

Building on or at the base of slopes characterized by landslides also involves predicting future landslide types and runout distances, particularly if rapid flow-type failures are possible. This is especially important because rapid-runout landslides have implications for life safety as well as property damage. Several recent landslides in areas characterized by both slow-moving rotational landslides and rapid, long-runout flow-type movements have demonstrated the importance of considering all likely types of landslides. The bluffs on the north side of the Weber River in the Washington Terrace area of southern Weber County are typically characterized by large, presumably slow-moving coherent rotational slides (Pashley and Wiggins, 1972), but a 1981 landslide in Washington Terrace (Gill, 1981) was a large, rapid, disrupted complex earth slide-earth flow that ran out a sufficient distance to knock a Union Pacific train off the tracks below the landslide and into the Weber River. Likewise, in the bluffs on the south side of the Weber River in South Weber, the 425 East South Weber Drive landslide in 2005 (figure 10; Giraud, 2005) and the 1650 East South Weber landslide in 2006 failed as rapid, shallow, long-runout slides and flows.

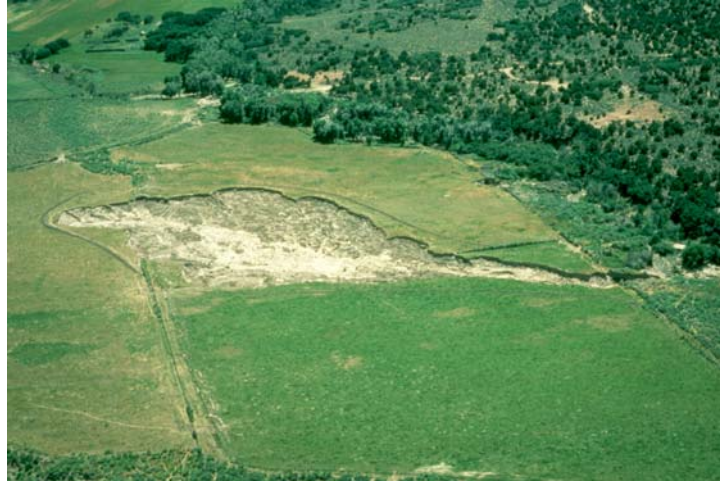
Figure 11. Evacuated area in alluvial-fan deposits along Gooseberry Creek in 1983 resulting from non-earthquake-induced liquefaction.

Similar flow-type failures have occurred due to non-earthquake-induced liquefaction in granular alluvial-fan deposits at very low slope angles of less than 4 degrees (7%) (Larrabee, 1984). During the record spring snowmelt in 1983, a flow failure in alluvial-fan deposits along Gooseberry Creek, a southern tributary to Salina Creek in Sevier County east of Salina, likely resulted from liquefaction caused by high

pore pressures which were heightened by infiltration from an unlined canal above the failure (figure 11).
